Craft: Halcyon 27: "Xebec"

Pre-purchase survey report

Survey date 10th February 2008

This is the survey report for Xebec, a Halcyon 27, said to have been built in 1970.

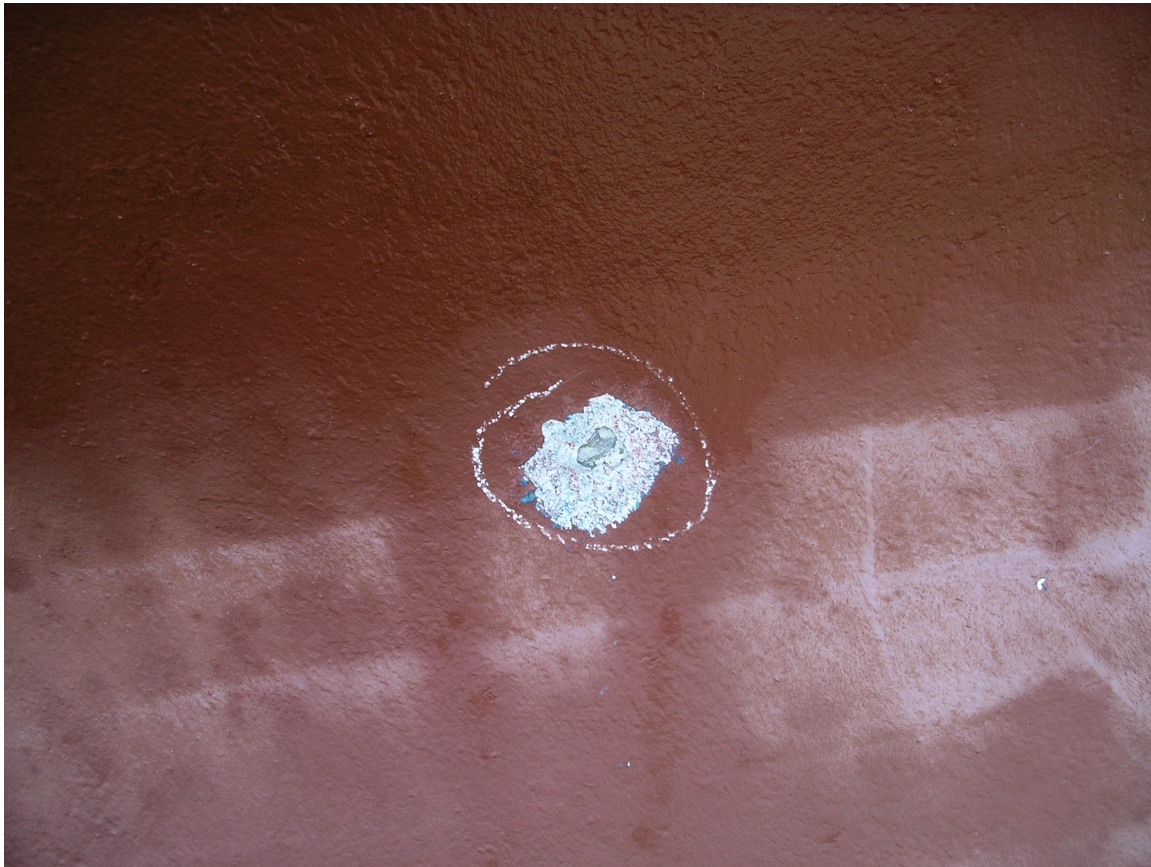
3.5 There was an area of the epoxy coat, 63cm forward of the propeller, port side, where the coat had failed and it was coming away to expose the fibreglass below. This is shown in photo 5386 below:

Photo 5386: area of epoxy failure on hull forward of propeller

3.9 The hull was sounded throughout with a hammer and it was found to be sound except at the area 63cm forward of the propeller as described in 3.5. There were no significant voids detected and no signs of de-lamination.

This area remained sound, but the area should be ground back to firm material and filled before re-launch.

Urgent action: grind back area where epoxy coat has failed and re-fill before re-launch.

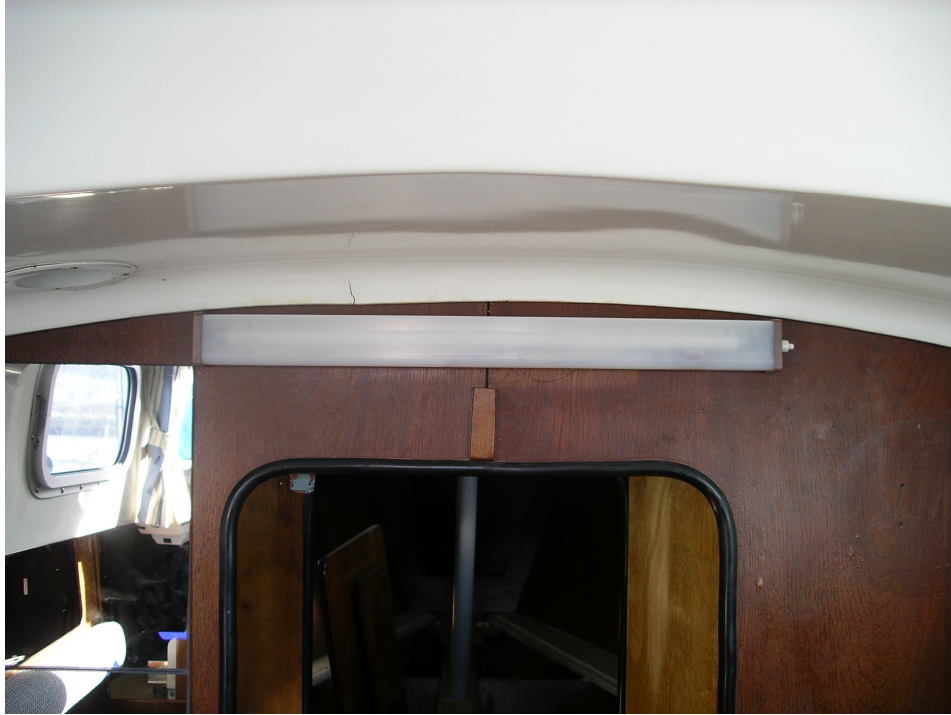
4.5 The mast was supported on a significant wooden plate that stretched between the 2 internal bulkheads. Internally, the second main bulkhead had a crack to the plastic lining port of centre, as shown in photo 5389 over the page:

Photo 5389: crack to lining around 2nd bulkhead

On deck, to starboard and aft of the mast, in line with the second bulkhead, there was a slightly raised area. The linings would have to be fully removed to ascertain the extent of any damage here, but no evidence of further damage was found. The cause of the defect could have been a large impact that twisted the bulkhead (starboard side going up, port side down), or the boat may have been manufactured like this initially. There were no signs of a large impact, as no other bulkheads were damaged and there were no other signs of twisting in the hull.
